Shorted Winding Assessment of Turboalternators

Mohamed A El-Sharkawi
Robert J. Marks
Isidor Kerszenbaum

The CIA lab
Department of Electrical Engineering
University of Washington
Seattle, WA 98195-2500
elsharkawi@ee.washington.edu
http://cialab.ee.washington.edu

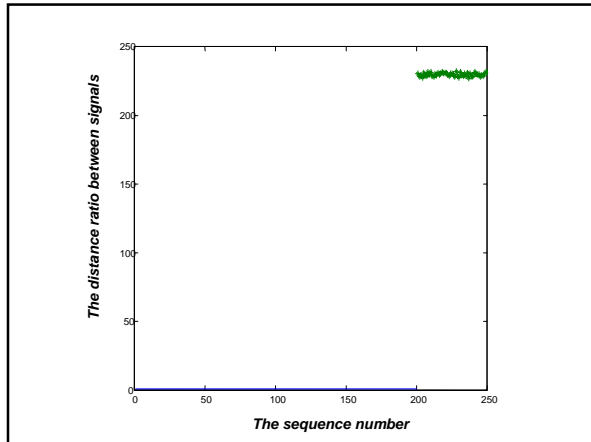
Lab Test: Effect of Speed

Rotor speed →	Stopped	30-60 rpm	1800 rpm
False Alarm rate α	0.0	0.0	0.4
Detection rate β	100.0	100.0	91.0

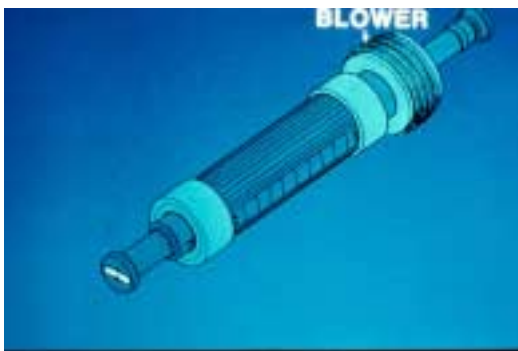
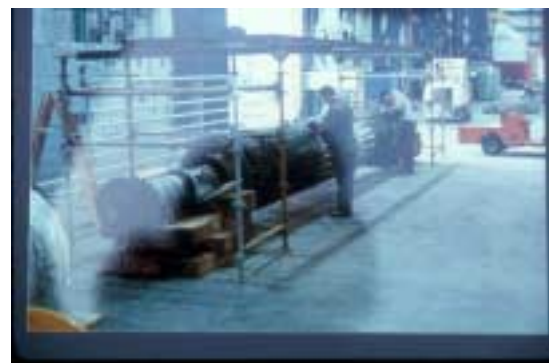
Field Test

- Southern California Edison Company
 - Unexcited Machine (60 MW rotor)
 - Fault is introduced
 - Excited Machine (60 MW rotor at Highgrove Power Station)
 - Fault cannot be introduced
 - Brush noise exists
 - Rotational noise - mechanical vibration
 - Electromagnetic noise
 - dc isolation
 - Fail safe operation

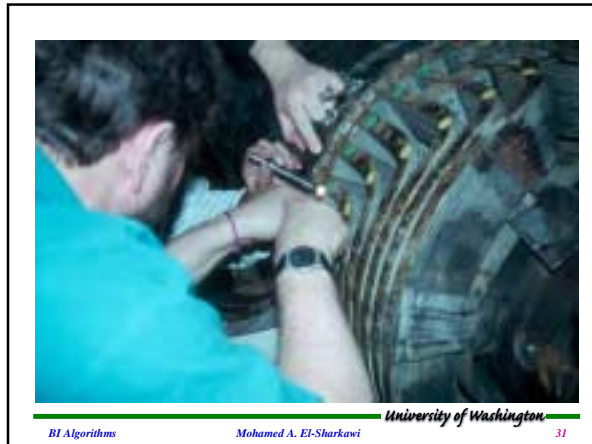
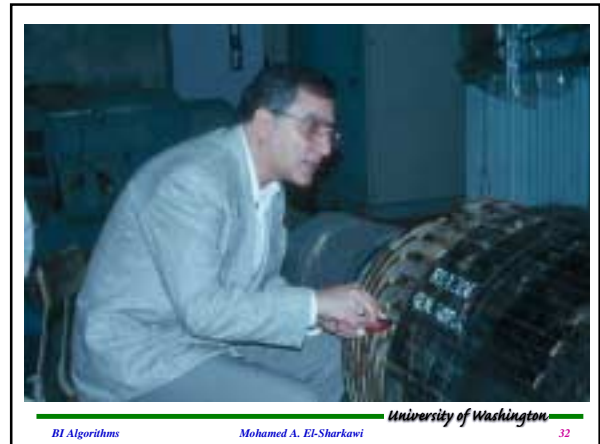
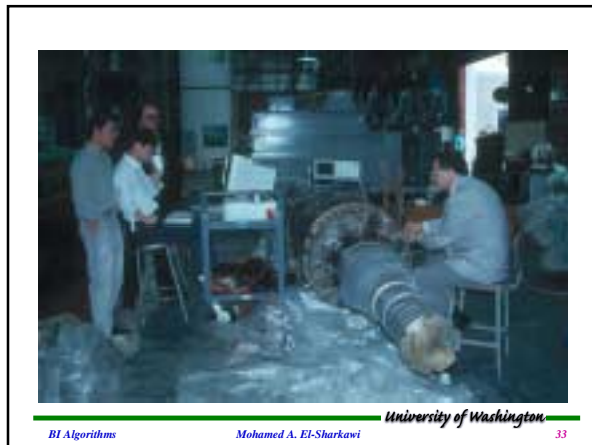
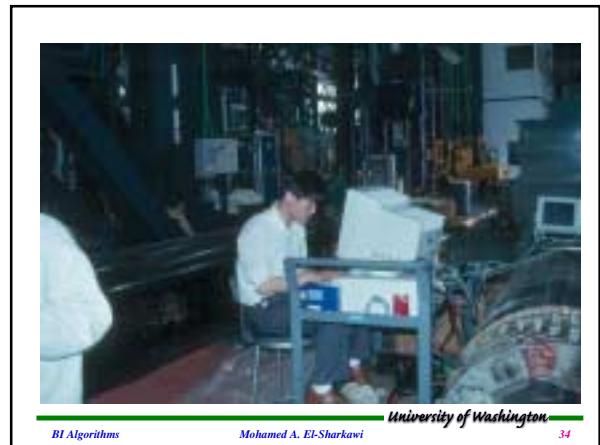
**Field Test Results:
Unexcited Machine**

Test Results	
Percentage of Accurate Identification of Coil	100%
Maximum error in short localization	± 7 turns ($\pm 3\%$)
